# INDOOR AIR QUALITY ASSESSMENT

## Country Elementary School Alphabet Lane Weston, Massachusetts

Prepared by:
Massachusetts Department of Public Health
Center for Environmental Health
Bureau of Environmental Health Assessment
Emergency Response/Indoor Air Quality Program
July 2004

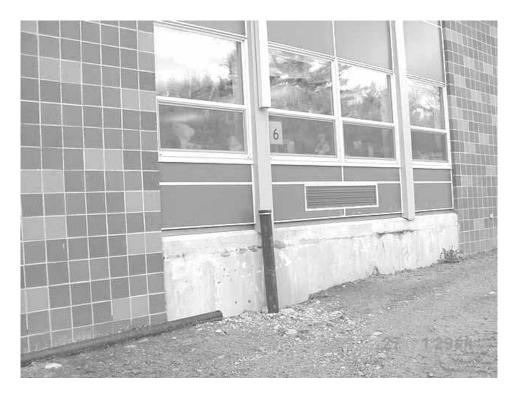
Fresh air in classrooms is supplied by a unit ventilator (univent) system. Univents draw air from outdoors through a fresh air intake located on the exterior walls of the building (Picture 1) and return air through an air intake located at the base of each unit (Figure 1). Fresh and return air are mixed, filtered, heated and provided to classrooms through an air diffuser located in the top of the unit. All univents in areas surveyed were operating, however, obstructions to airflow, such as items stored on univents and furniture near univent return vents were seen in a number of classrooms (Picture 2).

**Univent Fresh Air Intake**

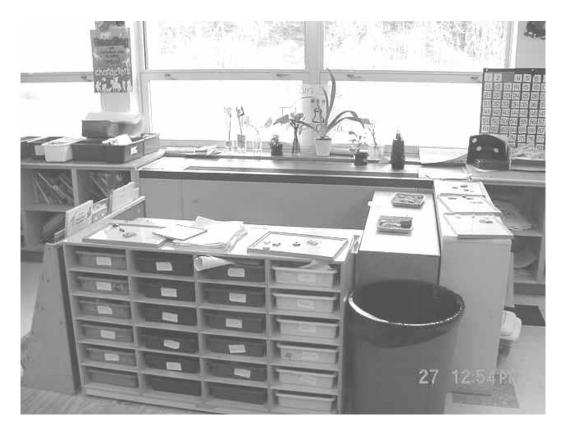
Furniture Configured around Univent Obstructing Airflow into Return Vent

- 6. Consider reconfiguring classrooms as necessary to facilitate air exchange between univents and exhaust vents. Ensure classroom doors are closed to maintain ceilingmounted exhaust vent function.

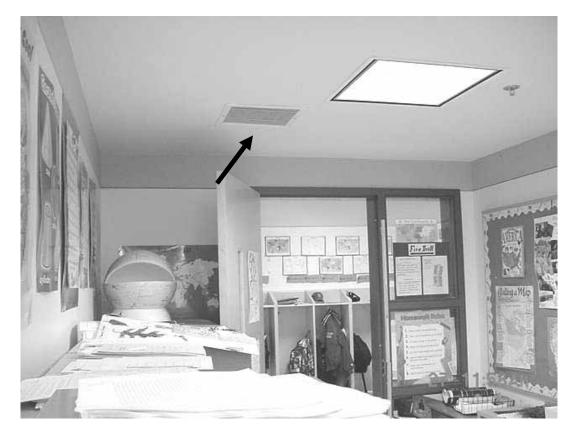
The mechanical exhaust ventilation system consists of ceiling-mounted exhaust vents connected to rooftop motors. This system was operating during the assessment. However, the location of some exhaust vents near hallway doors can limit exhaust efficiency when classroom doors are open (Picture 3). When a classroom door is open, exhaust vents will tend to draw air from both the hallway and the classroom. The open hallway door reduces the effectiveness of the exhaust vent to remove common environmental pollutants from classrooms.

Location of Classroom Exhaust Vent near Open Hallway Door

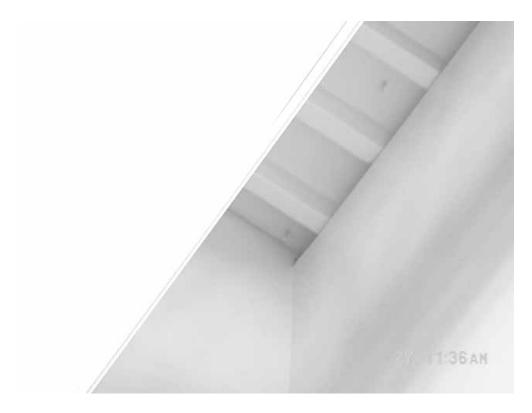
Signs of bird roosting and nesting were observed in a number of recesses around the exterior of the building (e.g., overhangs, building envelope penetrations) (Pictures 4 and 5). Birds can be a source of disease, and bird wastes and feathers can contain mold, which can be irritating to the respiratory system.

Interior View (from Cafeteria) of Area of Bird Ingress

The methods employed for cleaning of a bird waste problem depend on the amount of waste and the types of materials contaminated. The MDPH has been involved in several indoor air investigations where bird waste has accumulated within ventilation ductwork (MDPH, 1999). Accumulation of bird wastes have required the clean up of such buildings by a professional cleaning contractor. In less severe cases, the cleaning of the contaminated material with a solution of sodium hypochlorite has been an effective disinfectant (CDC, 1998). Disinfection of non-porous materials can be readily accomplished with this material. Porous materials contaminated with bird waste should be examined by a professional restoration contractor to determine whether the material is salvageable. Where a porous material has been colonized with mold, it is recommended that the material be discarded (ACGIH, 1989). Mr. Foley reported that Waltham Chemical, a pest control/management firm, was hired to remove bird nests and temporarily seal roosting areas with foam sealant. The WPSD and CCGI were also working with the architect and general contractor to permanently seal breaches in the building envelope.

- 1. Continue working with contractors and pest management consultants to remove birds' nests and wastes from the building. To prevent possible exposure to bird wastes, implement the corrective actions recommended by the CDC (CDC, 1998). To prevent possible spread of bird waste particulates to occupied areas, employ the methods listed in the SMACNA guidelines for Containment of Renovation in Occupied Buildings (SMACNA, 1995).

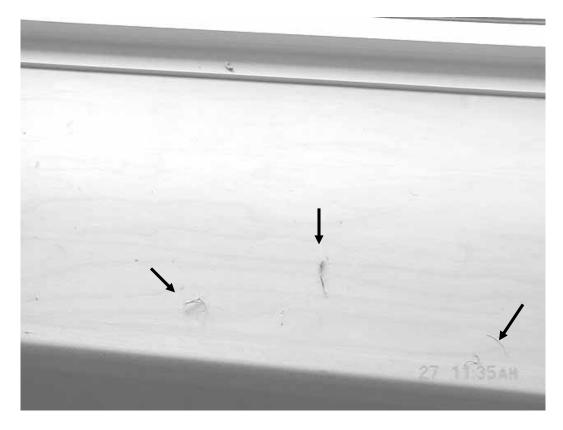
Bird Feathers and Nesting Materials on Windowsill in Cafeteria Beneath Area Shown in Picture 4

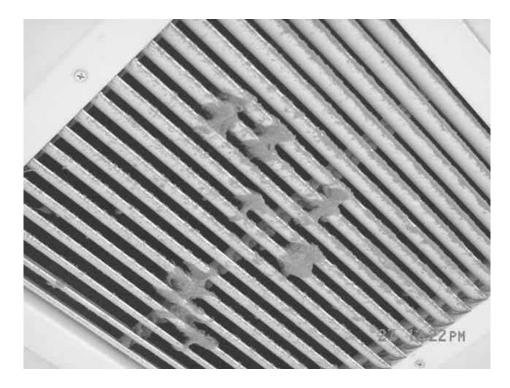
Several other conditions that can affect indoor air quality were noted during the assessment. A number of exhaust/return vents were noted with accumulated dust (Picture 6). If exhaust vents are not functioning, backdrafting can occur, which can re-aerosolize accumulated dust particles. Several rooms had missing and/or dislodged ceiling tiles (Picture 7). Missing/dislodged ceiling tiles can provide a pathway for the movement of drafts, dusts and particulate matter between rooms and floors.

**Dirt/Dust Accumulation on Exhaust Vents**

- 9. Clean exhaust/return vents periodically to prevent excessive dust build-up.
- 10. Replace missing/damaged ceiling tiles.
- 11. Pour water down floor drain in nurse's suite regularly (once/twice per week) to maintain water trap seal.

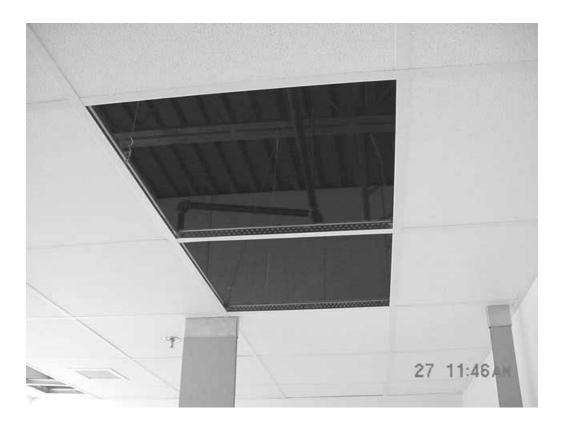
Missing Ceiling Tile in Classroom

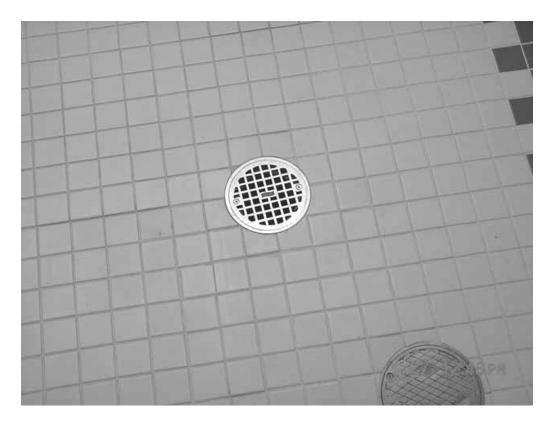
Finally, periodic sewer gas odors were reported in the nurse's suite. The floor in this area contains a drain (Picture 8). Drain traps are designed to form a water seal to prevent the backup of sewer odors. Without frequent input of water, the airtight seal on the trap can be breached resulting in the back up of sewer gas into occupied areas. Sewer gas can create nuisance odors and be irritating to certain individuals.

Floor Drain in Nurse's Suite
